# Property Condition Assessment

**100 Main Street, Anytown, ST 00000**

**RE** Property Condition Assessment of  
Garden Apartments  
100 Main Street  
Anytown, ST 00000

CREtelligent Project No.: SAMPLE-001

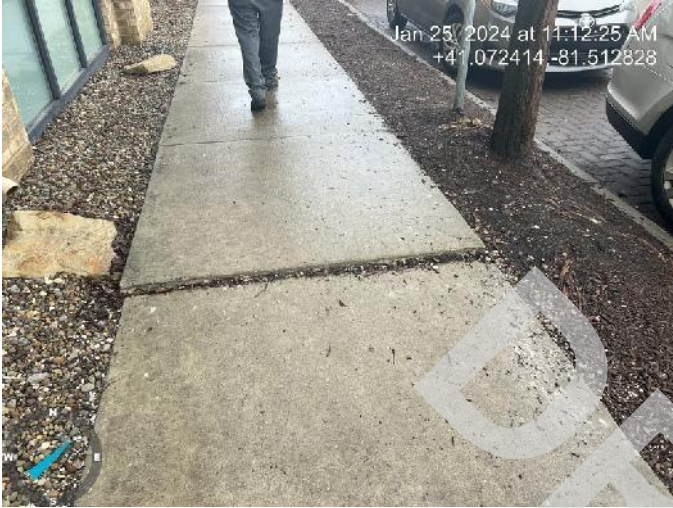
Areas of vertical displacement, creating potential trip hazards, were observed near Buildings A and D. Immediate repair is recommended. This work is included in the Cost Schedules as a Critical Repair Item. After repairs are completed, routine monitoring and maintenance are anticipated during the evaluation period.

Vertical displacement at Building A

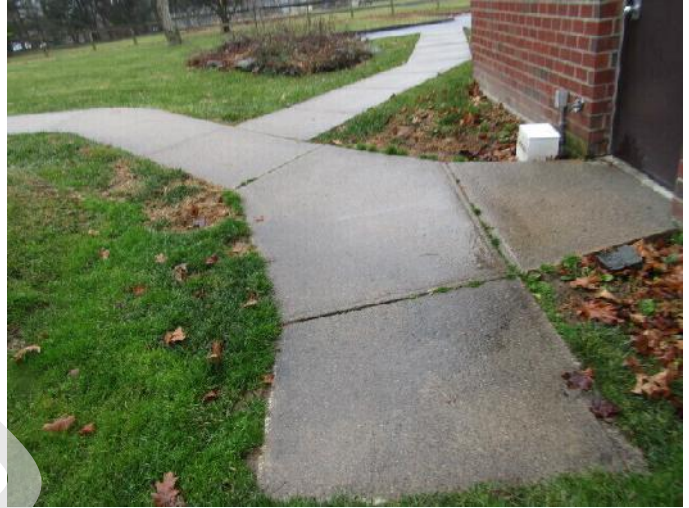
Vertical displacement at Building D

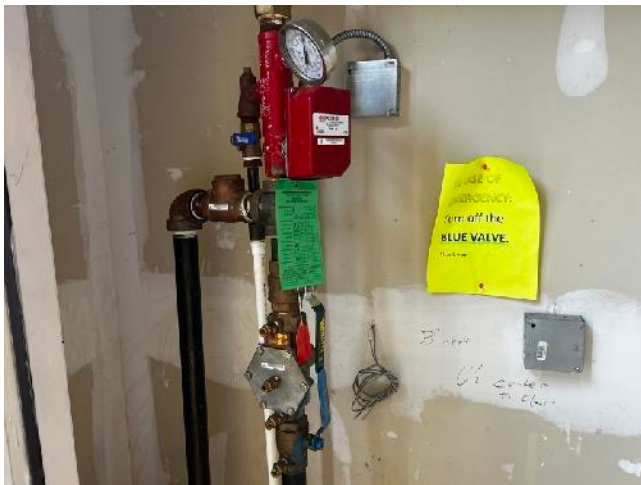
Expired inspection tags were observed on the fire sprinkler risers. Immediate inspection and certification of all fire sprinkler systems is recommended. This work is included in the Cost Schedules as a Critical Repair Item. After repairs are completed, routine monitoring and maintenance are anticipated during the evaluation period.

Fire sprinkler riser
