Property Condition Assessment

100 Main Street, Anytown, ST 00000

RE Property Condition Assessment of
Garden Apartments
100 Main Street
Anytown, ST 00000

CREtelligent Project No.: SAMPLE-001

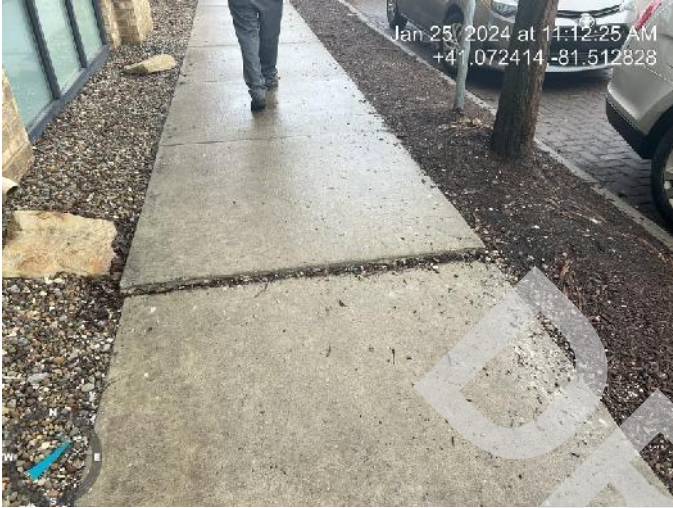
Areas of vertical displacement, creating potential trip hazards, were observed near Buildings A and D. Immediate repair is recommended. This work is included in the Cost Schedules as a PR-90 Repair Item. After repairs are completed, routine monitoring and maintenance are anticipated during the evaluation period.

Vertical displacement at Building A

Item	Repair Type	Unit of Measure	Quantity	Per Item Costs	Total Costs	Comments
Pedestrian paving/hardscape	PR-90	EA	2	\$300.00	\$600.00	
Subtotal					\$600.00

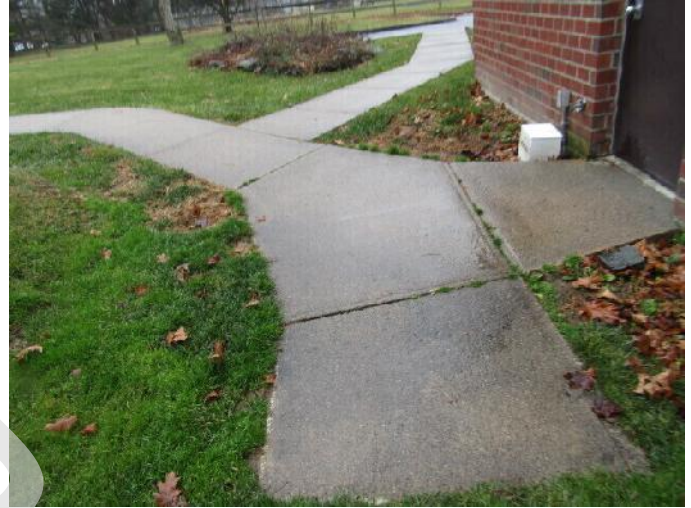
Vertical displacement at Building D

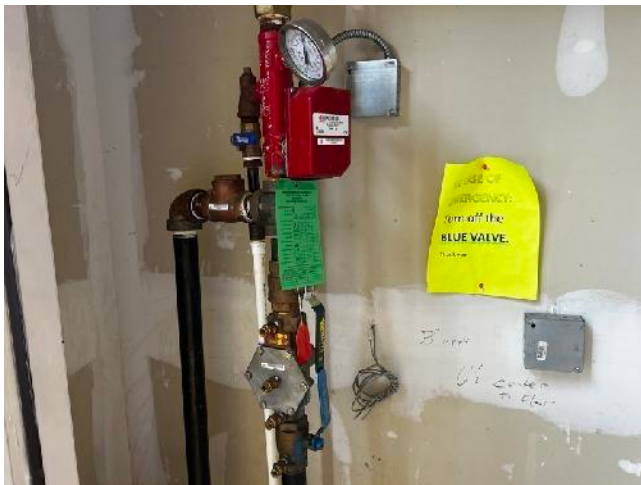
Expired inspection tags were observed on the fire sprinkler risers. Immediate inspection and certification of all fire sprinkler systems is recommended. This work is included in the Cost Schedules as a PR-90 Repair Item. After repairs are completed, routine monitoring and maintenance are anticipated during the evaluation period.

Fire sprinkler riser

Item	Repair Type	Unit of Measure	Quantity	Per Item Costs	Total Costs	Comments
Fire suppression	PR-90	EA	5	\$1,125.00	\$5,625.00	
Subtotal					\$5,625.00
